STUDY OF CONVENTIONAL TILE FIELDS IN FINE - GRAINED SOILS

REPORT NO. 74

December 1978

Applied Sciences Section
Pollution Control Branch
Ontario Ministry of the Environment

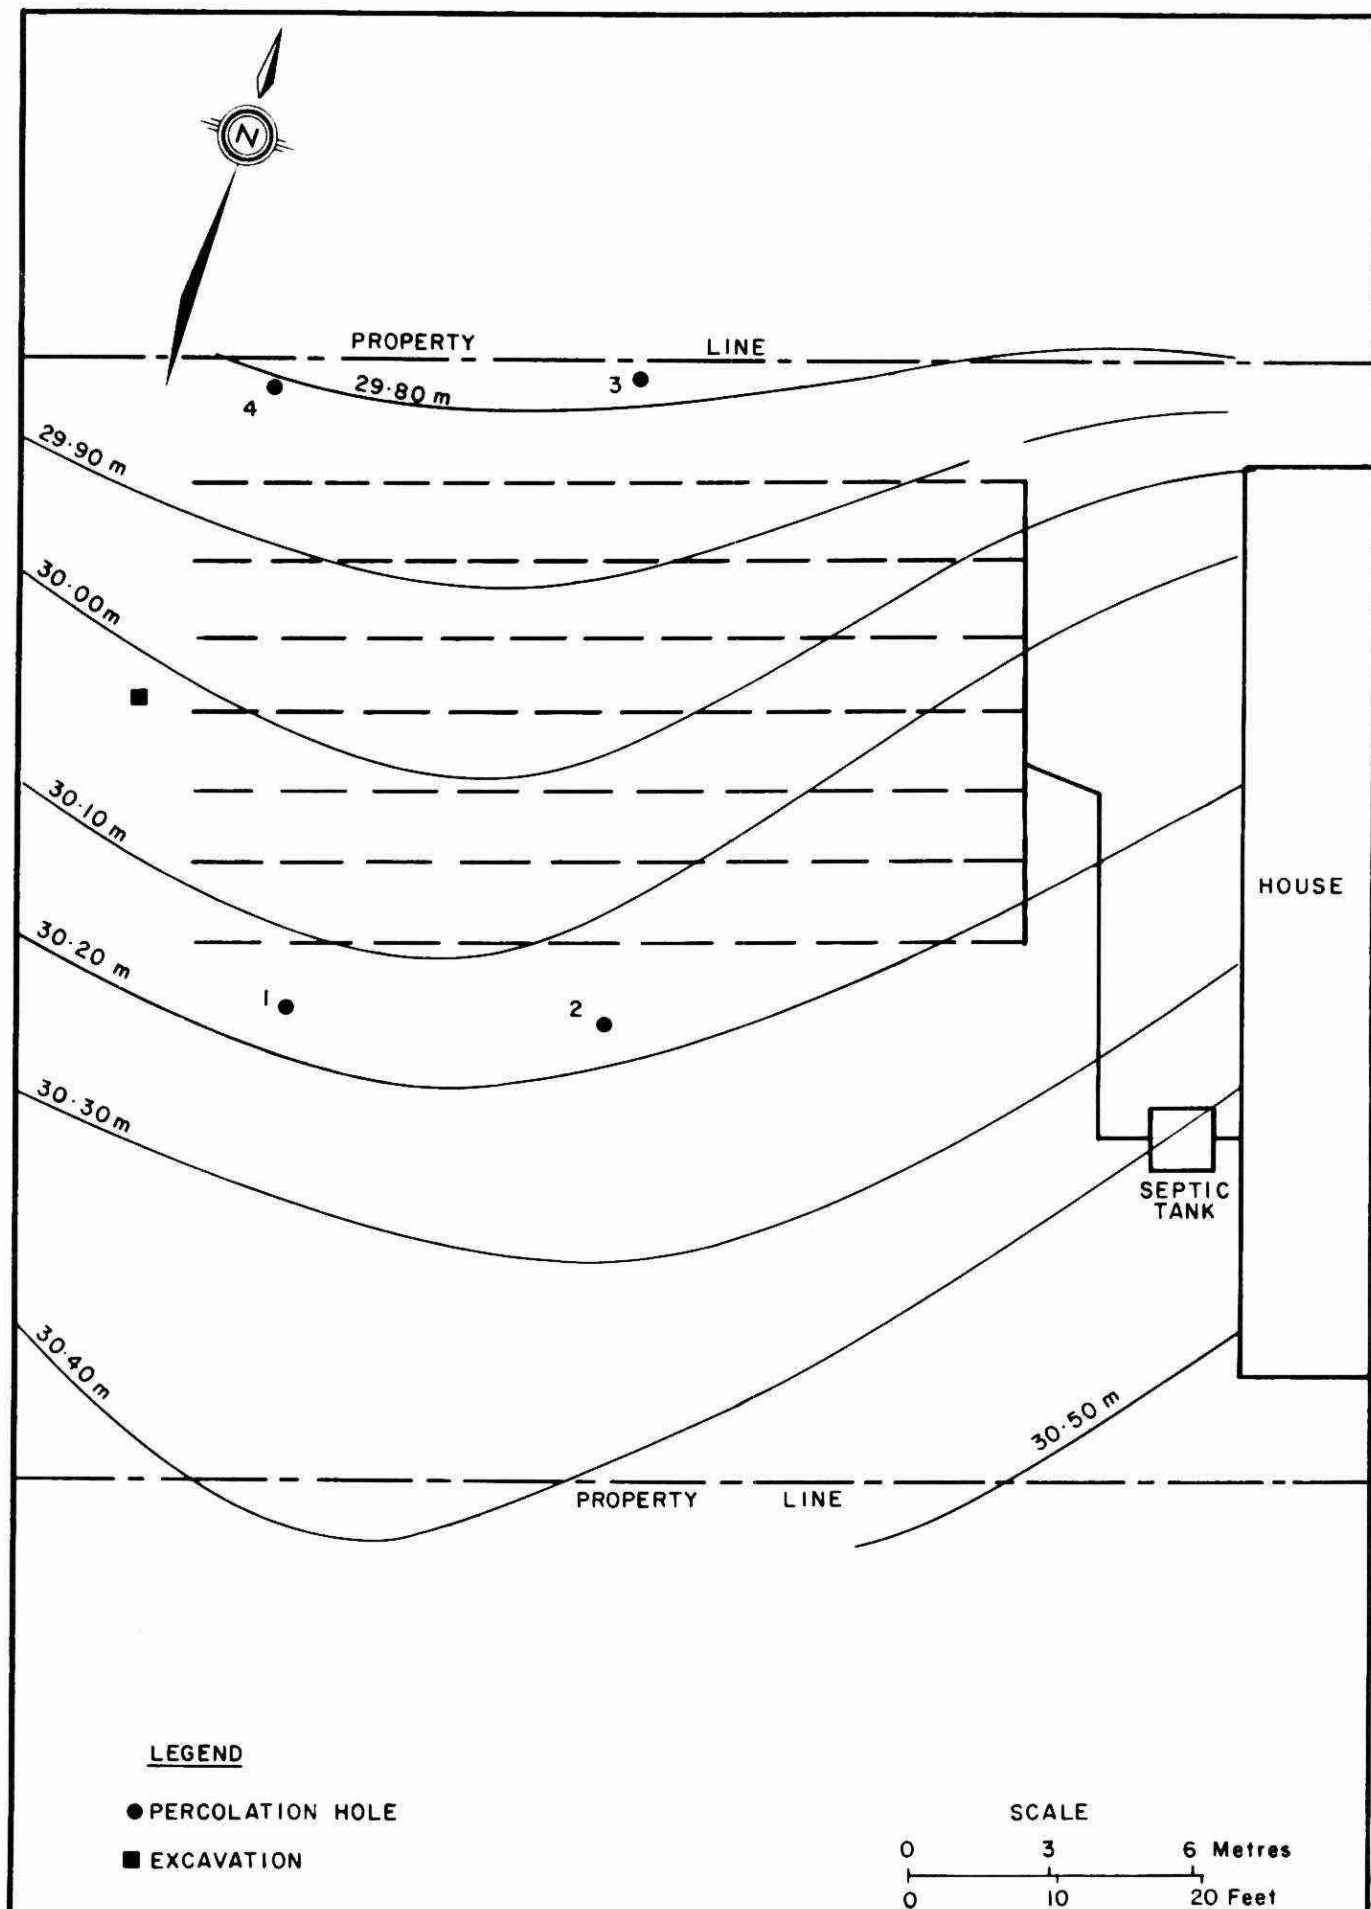
FIGURE II: LAYOUT, TOPOGRAPHY AND LOCATIONS OF PERCOLATION HOLES AT SITE B2.

Two small well points were installed in each tile trench to monitor the water level from July to November 1977. In August and September 1977, the water level in some of the well points was about 0.4 m (15 in.) below the ground surface, suggesting that some trenches were partially filled with septic tank effluent. However, observations made on the ground surface in the tile field area indicated that the system was operating satisfactorily. According to the owner of the house, the waste disposal system did not have any operational difficulties.

The laboratory results of hydraulic conductivity and the percolation test results obtained in test holes 2 and 3 indicated that the soil at the site was not too permeable. However, the test data from percolation holes 1 and 4 suggested much more favourable soil conditions. The percolation time in hole 4 was extremely small, a probable result of cracks and fissures in the soil. In summary, the test results showed a non-uniform soil condition. Therefore, it may be concluded that the tile field was partly built

in reasonably permeable soils, and coupled with the low hydraulic loading rate of $10.5 \text{ L/m}^2/\text{d}$ ($0.22 \text{ gals./ft.}^2/\text{day}$), the system would have experienced no difficulties in the disposal of the septic tank effluent.

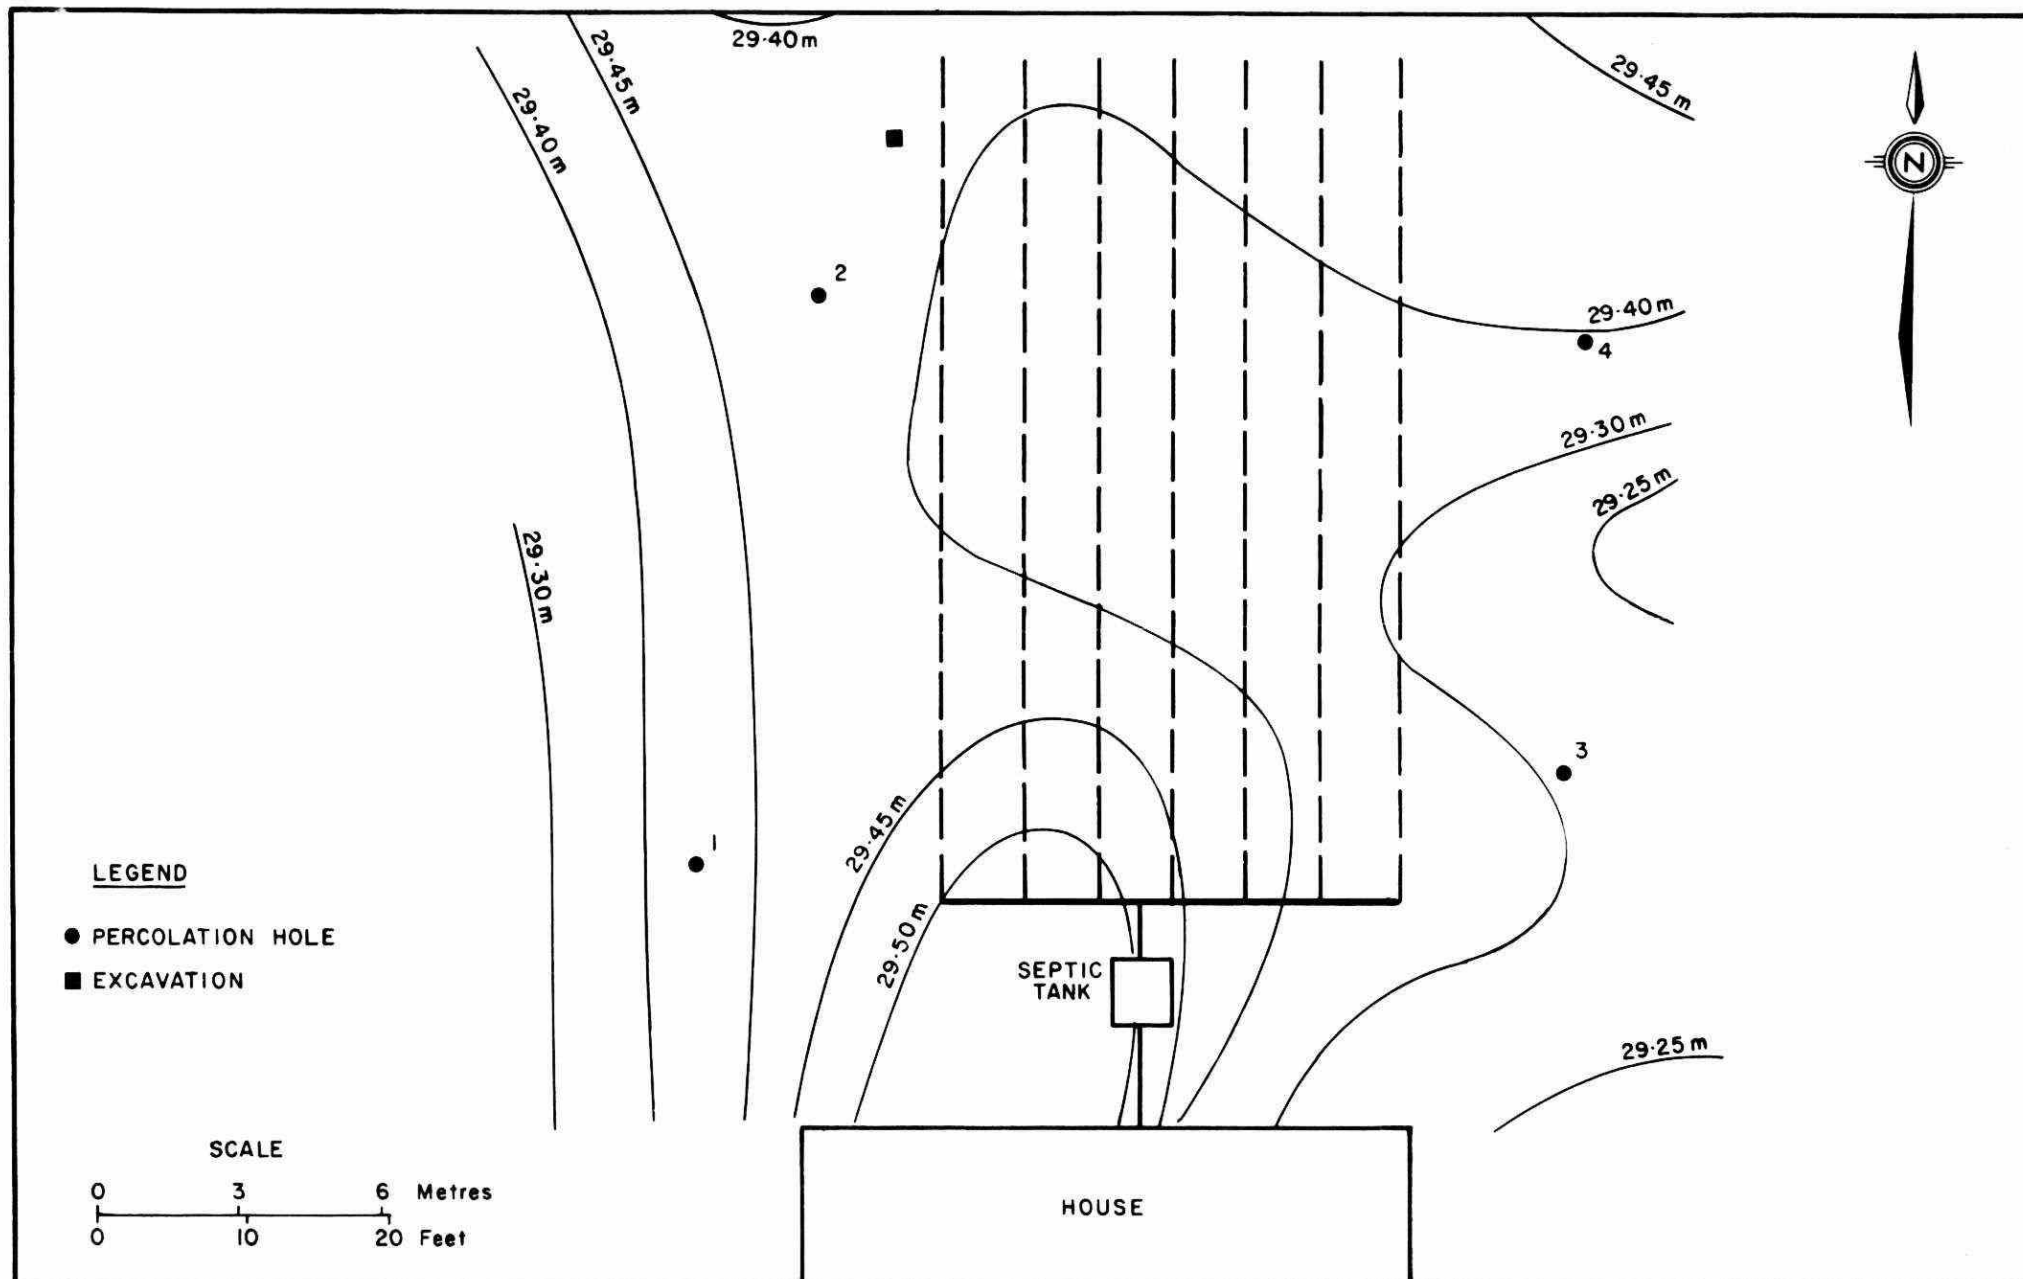
FIGURE 12: LAYOUT, TOPOGRAPHY AND LOCATIONS OF PERCOLATION HOLES AT SITE B-3

Figure 12 shows the topography of the site and the location of the tile field. As indicated by the ground surface contour lines, the site was quite flat. There were seven rows of tiles located at the depth of about 0.76 m (2.5 ft.). There were four people using the system and the hydraulic loading rate was $10.7 \text{ L/m}^2/\text{d}$ ($0.22 \text{ gals./ft.}^2/\text{day}$).

According to the owner of the dwelling, the septic tank-tile field experienced no operational difficulties all year round; and according to the water level measurements in the pipes installed in the trenches, the soil in the tile field apparently had no problems in absorbing the effluent from the septic tank during the field investigation period.

Referring to the results of the field percolation tests and the laboratory hydraulic conductivity measurements, the drainage or permeability characteristics of the soil appears to be very poor. This is not in agreement with the apparent satisfactory performance of the tile field at the site.

This inconsistency might be accounted for by the non-uniform nature of the soil, which could possess better drainage characteristics in some parts of the tile field. In addition, during the time of the field investigations, the effect of evapotranspiration might play a significant role in the disposal of the effluent from the trenches.

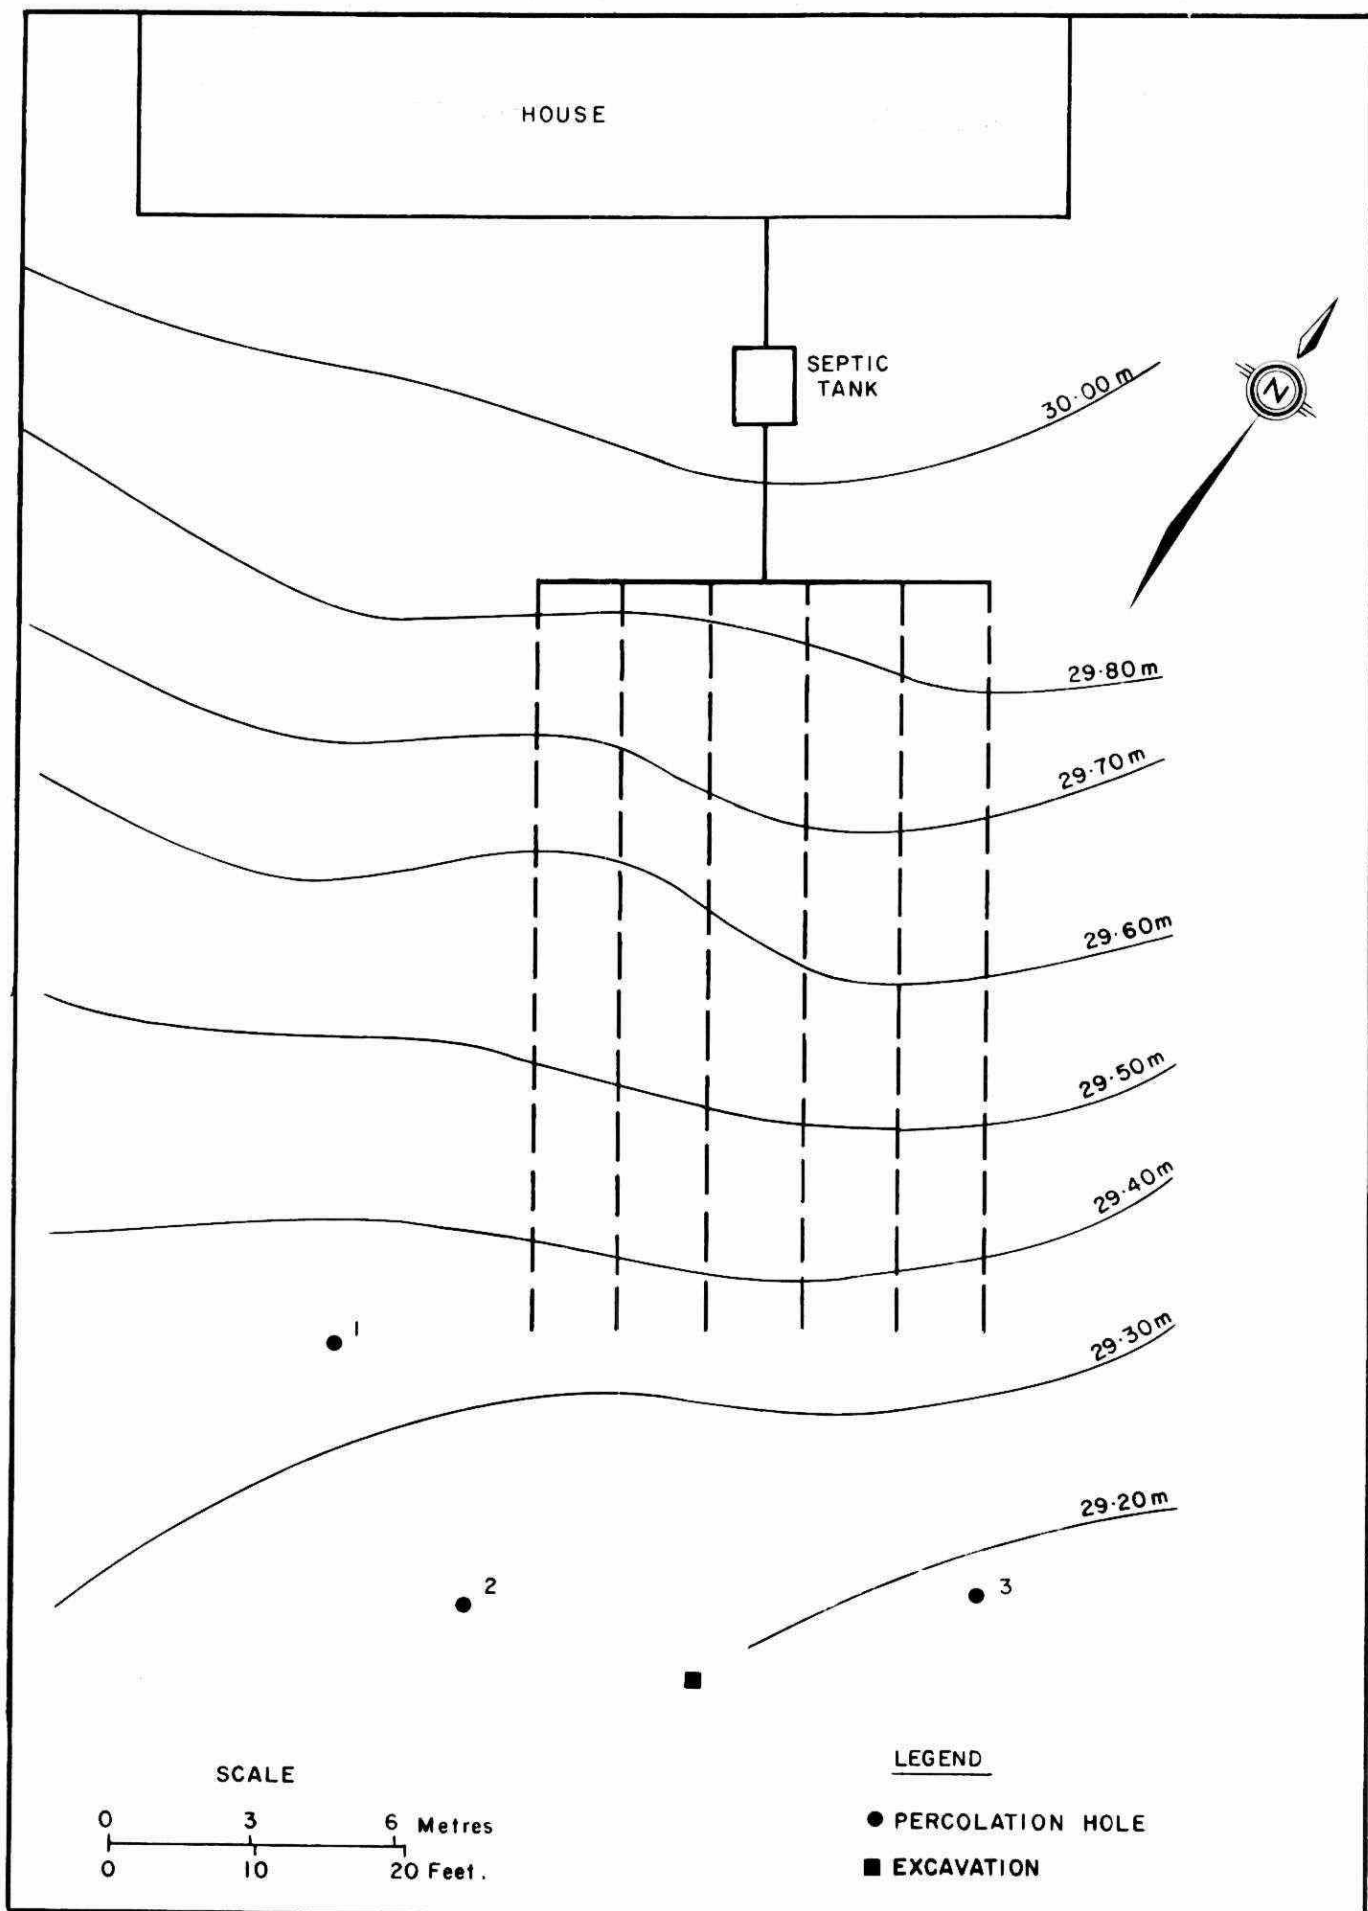
FIGURE 13: LAYOUT, TOPOGRAPHY AND LOCATIONS OF PERCOLATION HOLES AT SITE B4.

The layout of the tile field and the contour of the ground surface are shown in Figure 13. (Note: There were only 91.4 m (300 ft.) of tiles at this site). The depth of the tiles was approximately 0.4 m (1.3 ft.) below the ground surface which sloped gently towards the south. The well points installed on the site indicated that the water table was at the depth of about 1.5 m (5 ft.) and the small copper pipes installed above the tile trenches showed that the trenches were dry. There were three people (2 adults and 1 child) using the system and the hydraulic loading rate on the tile field was $14.9 \text{ L/m}^2/\text{d}$ ($0.31 \text{ gals./ft.}^2/\text{day}$).

During the time of the field investigation from July to November 1977, the tile field was working satisfactorily and showed no sign of ponding of septic tank effluent in the trenches, indicating that the soil had adequate adsorptive capacity for the septic effluent. The reasonably good performance of the tile field could be partly attributed to the low hydraulic

loading rate on the system and the climatic conditions at the time of the field investigation. However, the performance of the system did not appear to be substantiated by the percolation test results which suggested poor drainage conditions of the soil, but the hydraulic conductivity measurements on the soil samples suggested a reasonably good drainage characteristics of the soil. These apparent conflicting results may be explained by the non-homogeneous soil conditions at the test site. Referring to Table 3, the percolation time in hole 3 was much smaller than that in holes 1 and 2, which were located on one side of the tile field. It would seem probable that some area in the tile field was underlain by soil of poor drainage characteristics and some area was underlain by more permeable soil which was capable of absorbing the effluent from the septic tank.

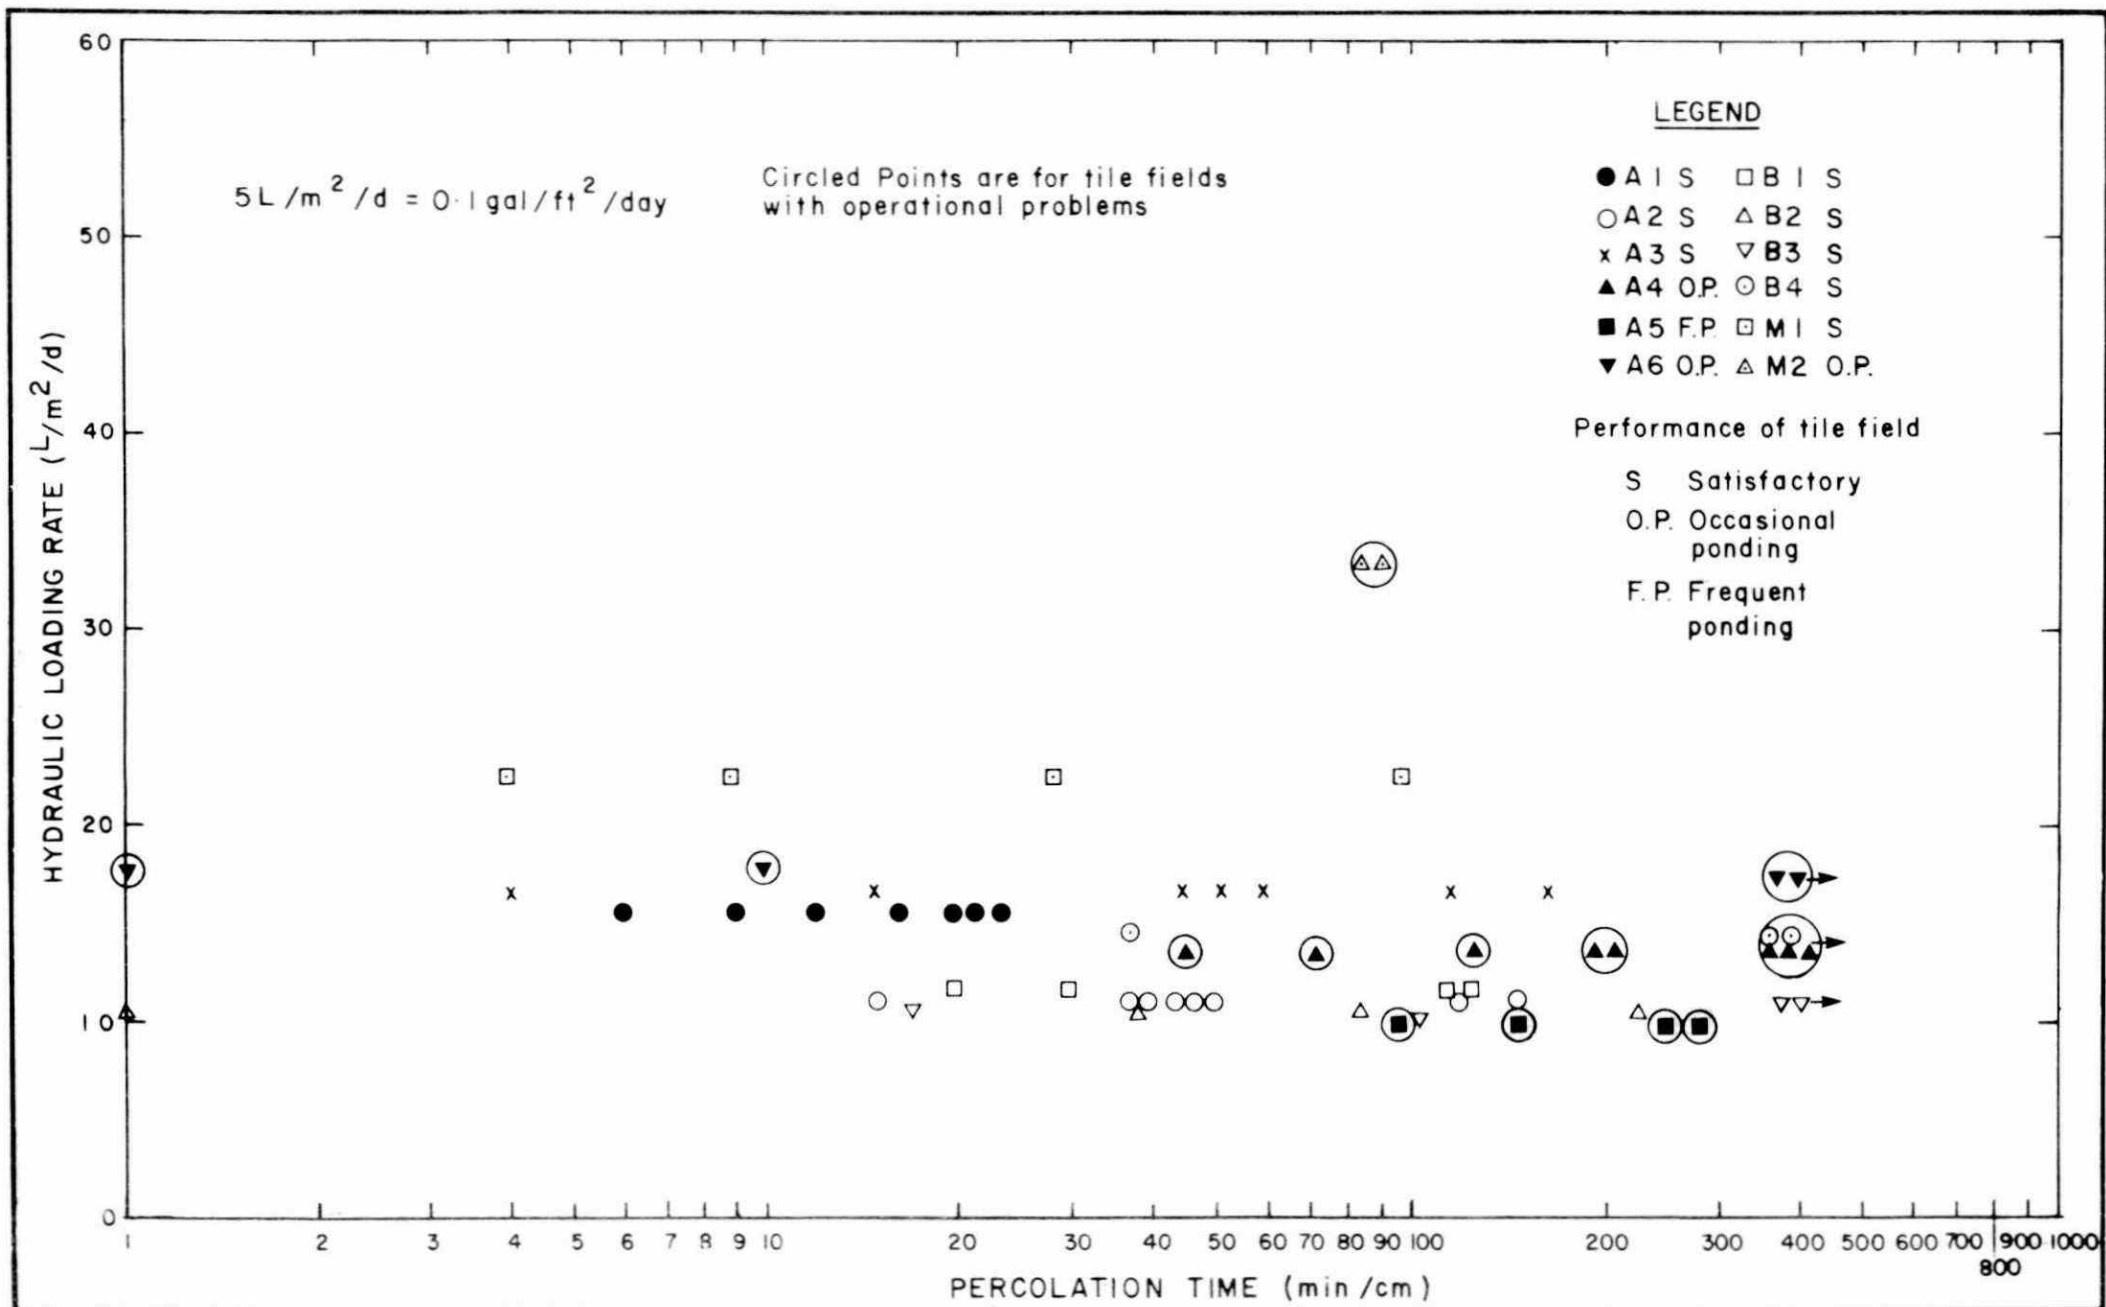
FIGURE 17: HYDRAULIC LOADING RATES ON TILE FIELDS Vs. PERCOLATION TIME OF SOILS

In Figure 17, the values of the "t" time of the soils at the twelve sites are plotted against the hydraulic loading rate on the tile field at each site. Referring to Figure 17, the four tile fields at sites A4, A5, A6 and M2 which had operational difficulties were installed in soils having "t" time values greater than 45 min./cm (excepting at site A6, the "t" times of the soil were extremely variable and there were two low "t" time values). On the other hand, the tile fields installed in soils with "t" time less than 45 min./cm generally worked satisfactorily with a hydraulic loading rate less than $23 \text{ L/m}^2/\text{d}$. As the "t" time value increases, the probability (or risk) of failure of the tile field also increases.

A relationship between the tile field loading rates and the "t" time was proposed by Ryon in the 1930's (Federick, 1948). Figure 18 shows this relationship for "t" times up to 30 min./cm (75 min./inch.). On the basis of extrapolating the data in Figure 18 and the results contained in Figure 17, it is recommended that soils with "t" times equal to 40 min./cm

(100 min./inch.) would still be acceptable for the installation of the conventional tile field provided that the hydraulic loading rate is less than $15 \text{ L/m}^2/\text{d}$ ($0.3 \text{ gals/ft.}^2/\text{day}$).
